# **GeoStudio Example File The Lower San Fernando Dam**

### Introduction

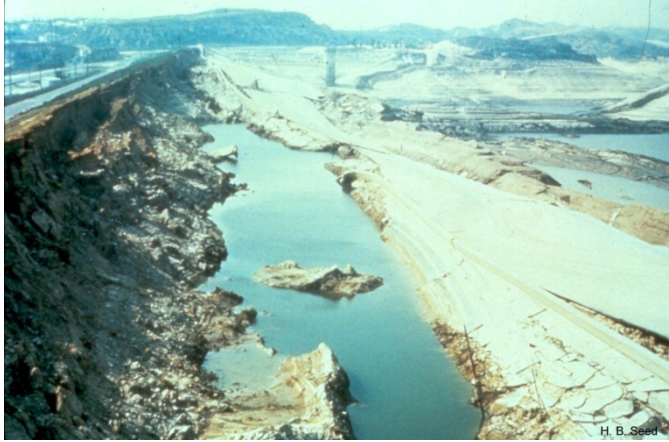
The earthquake shaking initiated a major failure on the upstream side of the dam. The photos in Figure 2, Figure 3 and Figure 4 show some of the conditions after the earthquake. Of significance is the very steep slide head scarp (Figure 2) and very marginal freeboard that remained after the failure.

Figure 2. Upstream face of the dam after drawing down the reservoir.

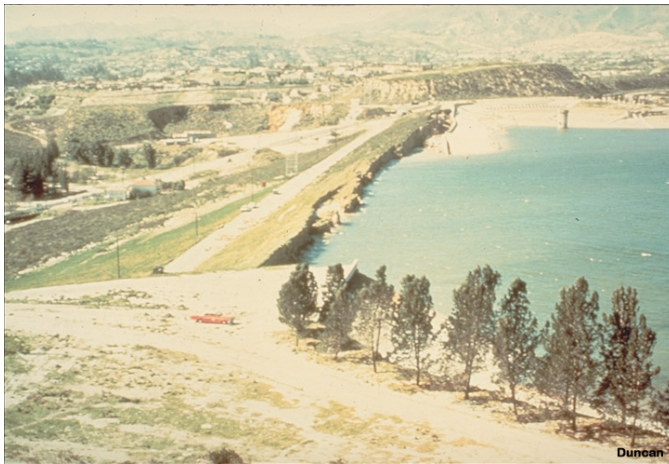
Figure 3. General view of the slide head scarp.

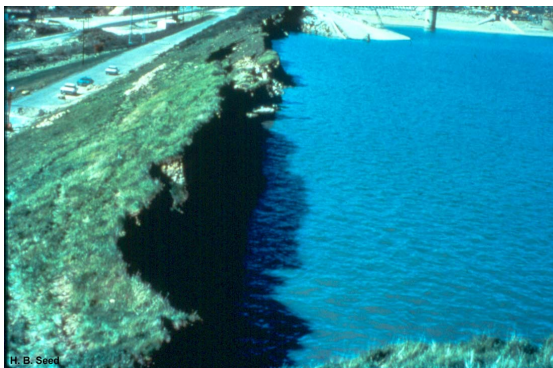
Figure 4. Close-up view of the slide head scarp.

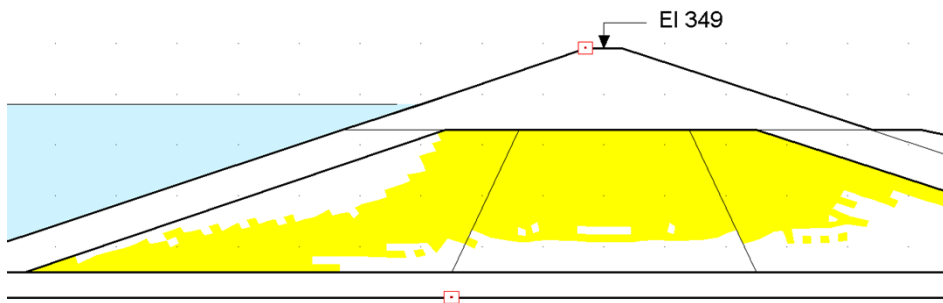
During the shaking, excess pore-water pressures will develop, causing other elements to reach the collapse surface or, in other words, to liquefy. Figure 21 shows the liquefied zone at the end of the shaking.

**Figure 21. Liquefied zone at the end of shaking.**

Of great significance is the shape and location of the liquefied zone on the downstream side. The shape and location is not unlike what Seed et al. determined what actually happened shown in Figure 22.

They came to the conclusion that, in all likelihood, there was a tongue-shaped zone in the lower position of the hydraulic fill that was at the root cause of the liquefaction and subsequent instability. The QUAKE/W liquefied zone on the downstream side in Figure 21 is somewhat similar.

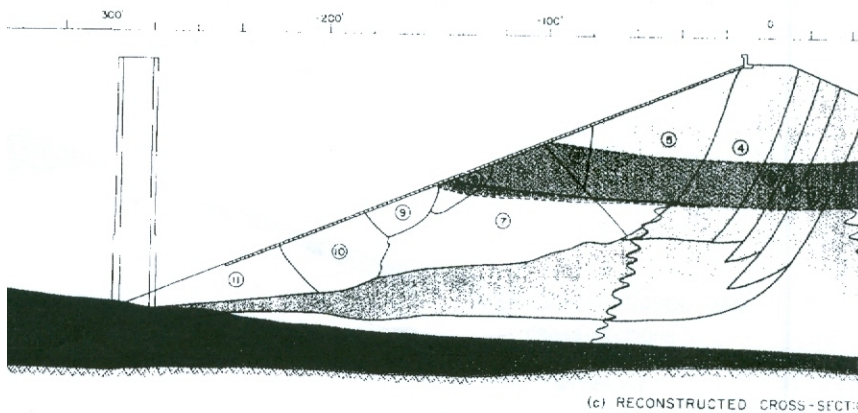
**Figure 22. Reconstructed section based on field investigations (after Seed et al.).**

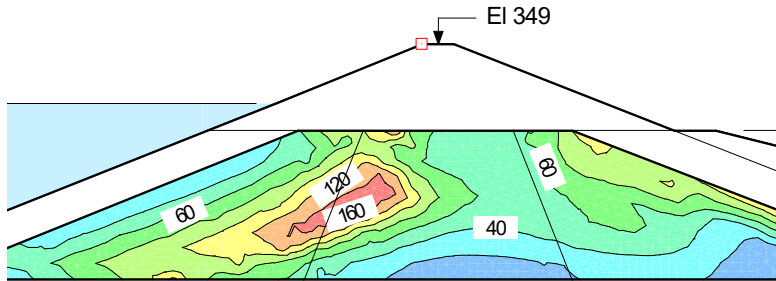
Figure 23 shows contours of the excess pore-water pressure at the end of the shaking. Of interest is the pocket of very high excess pore-water pressures right in the tongue-shaped area Seed et al. considered to have liquefied. It is also of interest that this pocket is in a position where there could potentially be a slide slip surface.

Figure 23. Contours of excess pore-water pressure at the end of shaking.

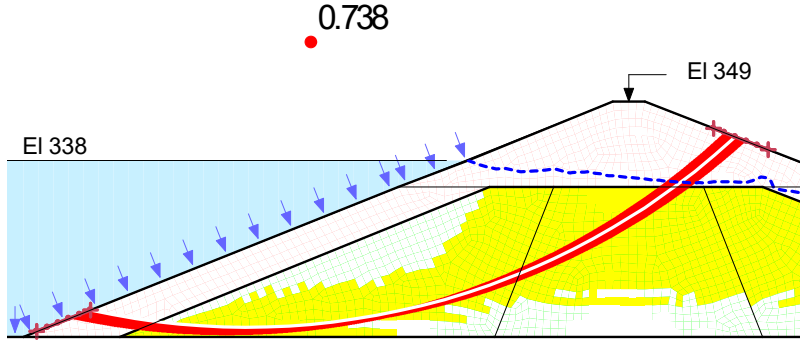
SLOPE/W has the capability to use the specified steady-state strength  $C_{ss}$  along the portion of a potential slip surface that passes through an element that QUAKE/W has marked as liquefied. Repeating the pre-earthquake stability analysis, but with post-earthquake pore-water pressures and with  $C_{ss}$  strengths in the liquefied zones, results in a factor of safety of less than unity (1.0), which clearly was the case (Figure 24).

Figure 24. Post-earthquake stability.

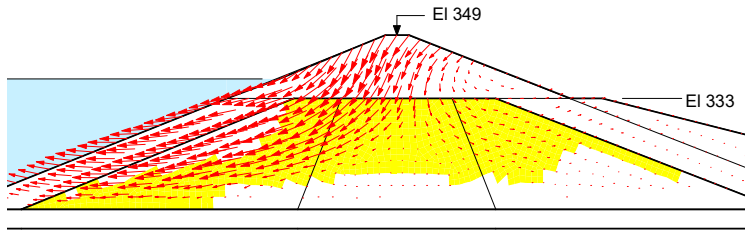
Figure 27 shows the displacement vectors from the post-earthquake SIGMA/W stress re-distribution. The movements seem to be a reasonable approximation of what happened as the movement started. In the crest area, the start of the movement is close to where the head scarp was, and the movements are downward at a steep angle, which is consistent with the actual head scarp (Figure 2). On the left side, much of the movement is more or less horizontal, which is also consistent with the observations presented in the published literature.

**Figure 27. Post-earthquake movement directions.**
