# **GeoStudio Example File Upper San Fernando Dam**

### Introduction

In light of the importance of the San Fernando Dam case histories and their prominence in the literature, it is important to show how GeoStudio, and in particular QUAKE/W, can be used to analyze cases like this. This example concentrates on the Upper Dam.

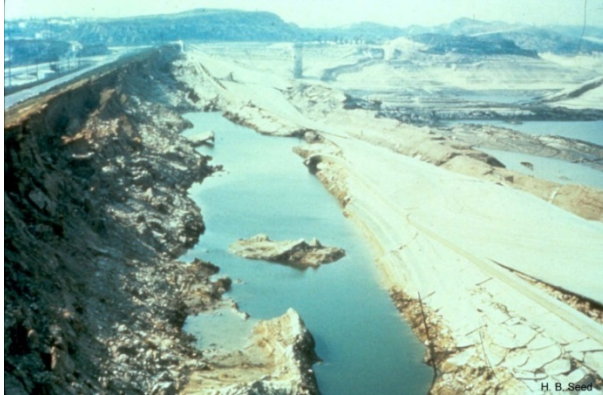
The earthquake shaking initiated a major failure on the upstream side of the dam. The photos in Figure 2, Figure 3 and Figure 4 show some of the conditions after the earthquake. Of significance is the very steep slide head scarp (Figure 2) and very marginal freeboard that remained after the failure.

Figure 2. Upstream face of the dam after the drawing down the reservoir.

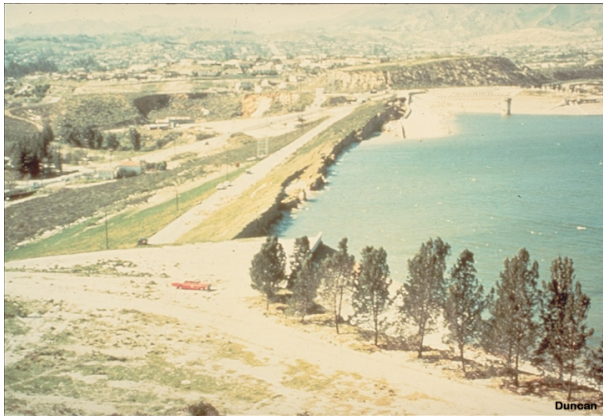
The failure led to a perilously close catastrophe. Had the head scarp been slightly lower, the outflow from the reservoir would have quickly eroded the dam and flooded many communities downstream. Considering the extremely precarious situation, some 80,000 people over an 11-square-mile area were evacuated while the reservoir was emptied over a period of three to four days.

Figure 3. General view of the slide head scarp.

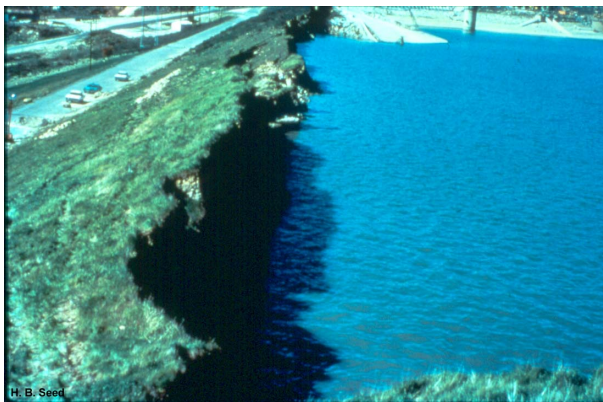
Figure 4. A close-up view of the slide head scarp.

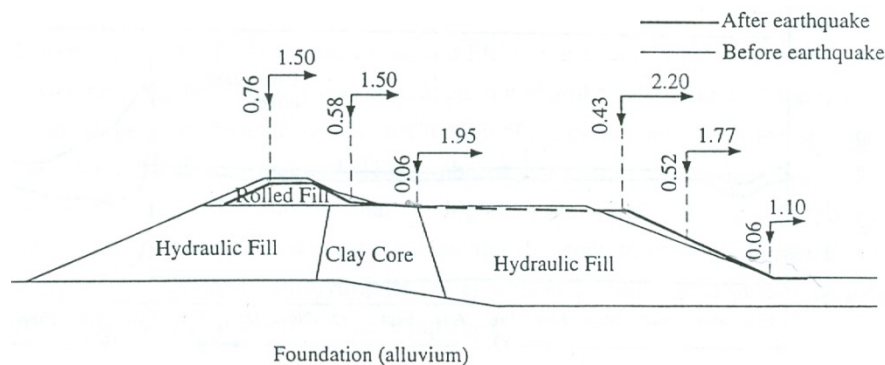
Surveys taken after the earthquake revealed that the entire upper portion of the dam had moved downstream around 2 m and the crest had moved downward around 0.75 m. Based on the sketch in Figure 5, only the upper rolled-fill portion moved on the upstream side. Of significance is the movement along the surface of the berm. Here, the movements were predominantly in the lateral direction with hardly any settlement (Figure 6).

**Figure 6. Movements associated with the earthquake.**

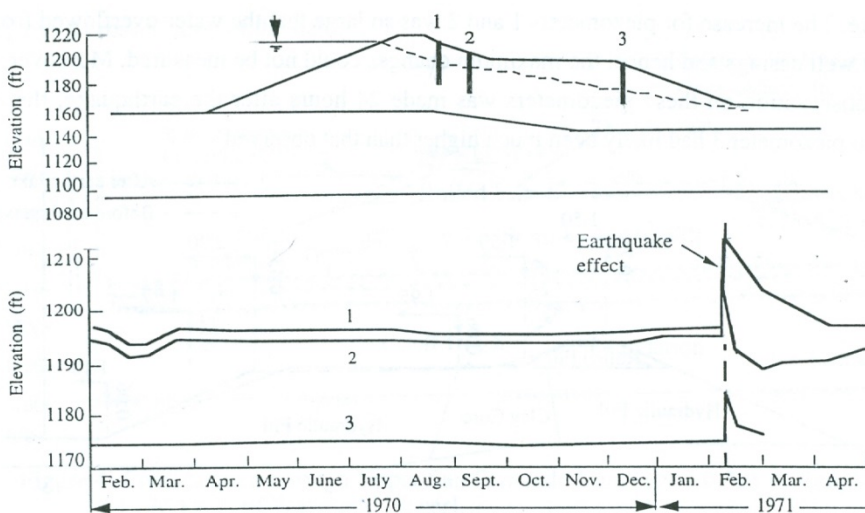
There were three piezometers in the dam (Figure 7). As indicated by the piezometric records, there was a sudden and dramatic increase in pore-water pressures. Even 24 hours after the earthquake, water was still running out of the top of Piezometers 1 and 2. This is of significance, since these piezometers are in the core area of the dam, especially Piezometer 2. The peak in Piezometer 3 was likely higher than what was measured, due to some dissipation within the 24 hours between the event and the readings. These piezometers provide definitive evidence that substantial excess pore-water pressures resulted from the shaking.

**Figure 7. Piezometers and pore-water pressure responses due to the shaking.**

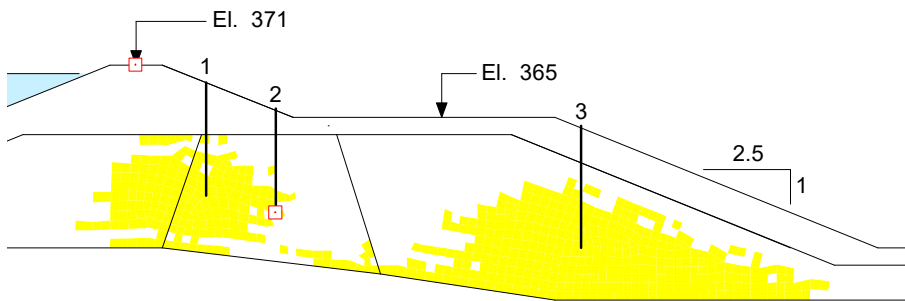
During the shaking, excess pore-water pressures will develop, causing other elements to reach the collapse surface as discussed earlier; in other words, to liquefy. Figure 25 shows the liquefied zone at the end of the shaking.

Figure 25. Liquefied zone at the end of shaking.

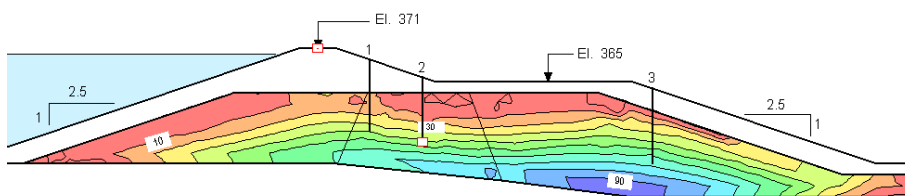
Figure 26 shows contours of the excess pore-water pressure at the end of the shaking. The highest excess pore-water pressures (90 kPa) are at the bottom of the hydraulic fill below the downstream berm crest.

Figure 26. Contours of excess pore-water pressure at the end of shaking.

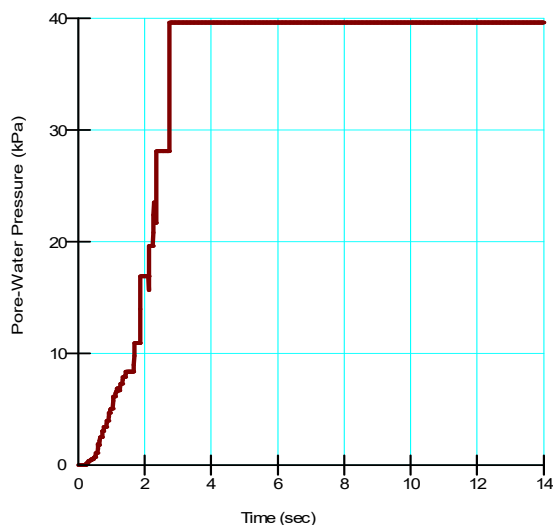
Figure 27 shows the build-up of excess pore-water pressures at the bottom tip of Piezometer 2. The maximum excess pore-water pressure is 43.5 kPa. This is a pressure head of 4.4 m (about 14.5 feet).

**Figure 27. Excess pore-water pressure at Piezometer 2.**

The View Results Information command can be used to get the final total  $H$  at the base tip of Piezometer 2. The computed  $H$  is 369 m. The ground surface at Piezometer 2 is 366 m. The total head  $H$ , being greater than the ground surface elevation, means water would be flowing from the piezometer casing, which is in keeping with observations.

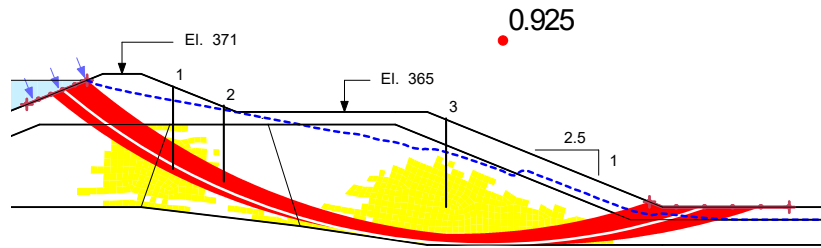
Figure 28. Post-earthquake overall stability.

It is of significant interest that the overall critical slip surface in Figure 28 on the upstream face is exactly in the area where large longitudinal cracks had formed under the reservoir water surface. These cracks only became visible after the reservoir was drawn down, some 12 days after the earthquake.

The safety factor for the overall stability case is 0.923 if the steady-state strength is used in the liquefied zones of the dam (Figure 28) as compared to 1.11 using the collapse surface properties ( $\phi' = 20$ ;  $C_{ss} = 35$  kPa) and 1.28 using effective stress strength properties ( $\phi' = 34$ ). In the downstream local case, the safety factor is 0.885 if the steady-state strength is used in the liquefied zones of the dam (Figure 29) as compared to 0.978 using the collapse surface properties ( $\phi' = 20$ ;  $C_{ss} = 35$  kPa) and 1.054 using effective stress strength properties ( $\phi' = 34$ ). Consequently, it could be argued that, in the local downstream case, the  $C_{ss}$  strength is not

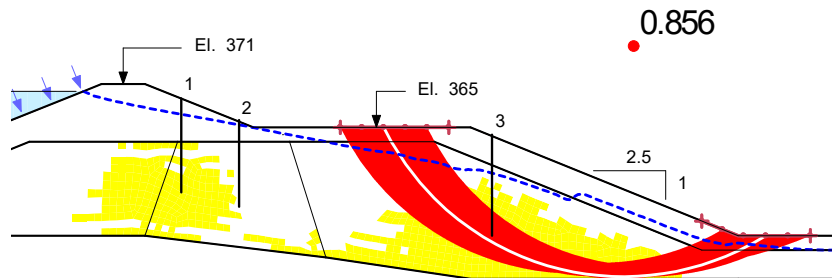
Figure 29. Post-earthquake stability of the downstream slope at the end of the earthquake.

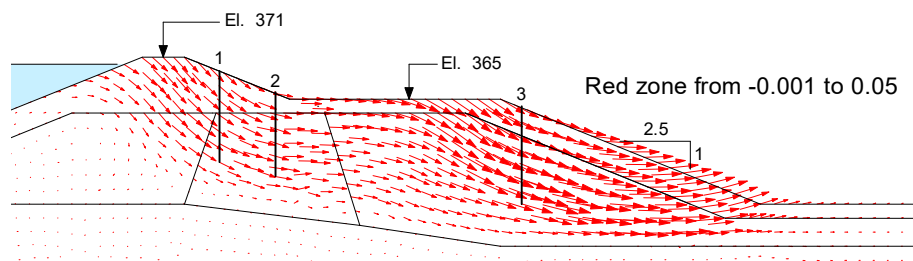
Figure 31 shows the displacement vectors from the post-earthquake SIGMA/W stress re-distribution. The movement patterns seem to be a reasonable approximation of what actually happened. The vectors in the upper rolled fill section are down and to the right, and the movement vectors start on the upstream face in the area where the longitudinal cracks developed. To the right of the upper rolled-fill section, the movement is predominately horizontal, which is also consistent with the observations discussed earlier.

**Figure 31. Post-earthquake movement directions.**

There seems to be, in part, a localized failure on the downstream side. The movements are greater in this area than further upstream. They are distinctly downward at the crest, and lateral and upward at the toe. The strong lateral movements in the toe area are consistent with the pressure ridge that had formed here, the compression failures observed in the outlet conduit and the down slope tipping of the concrete manhole. The movement vectors, in general, are somewhat characteristic of a localized near circular slip failure.

Generally, the computed movement patterns are entirely consistent with the field observations, and the conclusions arrived at by Seed et al. They concluded that, the *zone of movements within the dam extended vertically over a large portion of the embankment and was not limited to well-defined slip surface at depth*. The computed movement patterns in Figure 31 certainly confirm this.

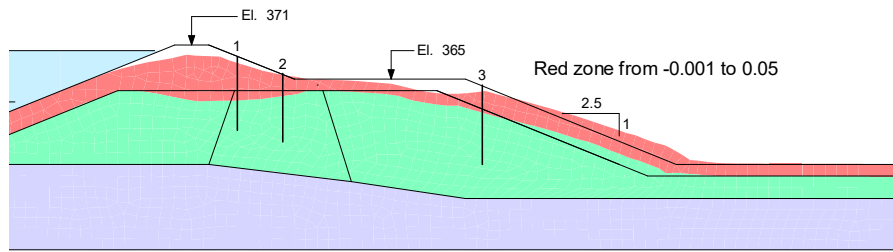
Another way to view the movements is as a deformed section (Figure 32). The view gives an appreciation of the down and right movement of the upper rolled fill section and compression bulging in the downstream toe area.

**Figure 32. A deformed section at a 20X exaggeration.**
