# **GeoStudio Example File Upper San Fernando Dam**

### Introduction

In light of the importance of the San Fernando Dam case histories and their prominence in the literature, it is important to show how GeoStudio, and in particular QUAKE/W, can be used to analyze cases like this. This example concentrates on the Upper Dam.

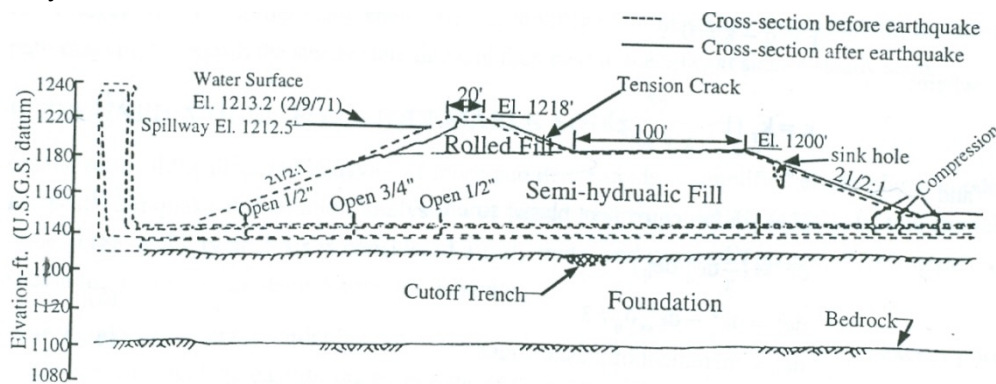
### Figure 5. Sketch of the Upper San Fernando Dam.

The Upper San Fernando Dam was constructed directly on the native streambed alluvium (Figure 5). The main body of the dam was constructed by what is known as a semi-hydraulic fill method. The material was hauled to the site by wagons and dumped into a pond where it was dispersed by water jets operating from barges. Although there is no mention of it in the publications, this technique must have created an outer shell of material compacted to some degree by the construction traffic. The material for this portion of the dam was obtained from the valley floor.

The hydraulic fill method was used up to El. 1200 feet (365 m) and then was topped-off with compacted fill to El. 1218 (371 m). This resulted in a 100-foot berm on the downstream side.

Surveys taken after the earthquake revealed that the entire upper portion of the dam had moved downstream around 2 m and the crest had moved downward around 0.75 m. Based on the sketch in Figure 5, only the upper rolled-fill portion moved on the upstream side. Of significance is the movement along the surface of the berm. Here, the movements were predominantly in the lateral direction with hardly any settlement (Figure 6).

The low level outlet conduit was inspected after the earthquake, and the condition of the conduit provided some interesting clues about the movement that occurred. On the upstream side, the conduit was extended as indicated by the openings noted in Figure 5. Toward the downstream toe, however, the conduit was forced into compression, as indicated by compression failures.

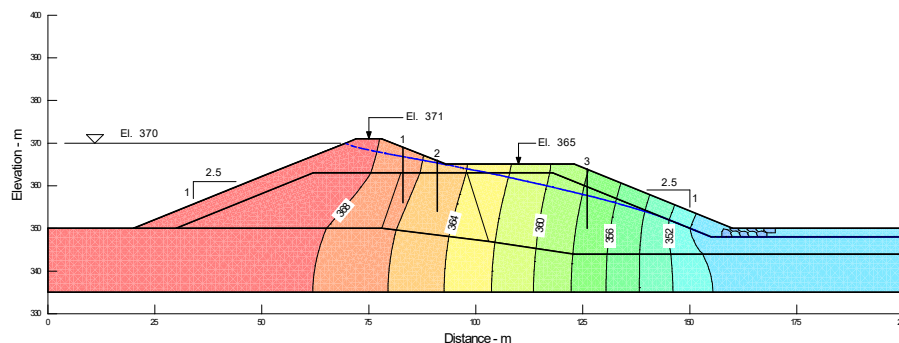
Figure 17. Long term steady-state seepage and pore-water pressure conditions.

Figure 17 shows the resulting piezometric line (water table) and total head contours (equipotential lines) for the initial SEEP/W analysis. Note that the piezometric line comes very close to the ground surface at the toe of the upper rolled section.

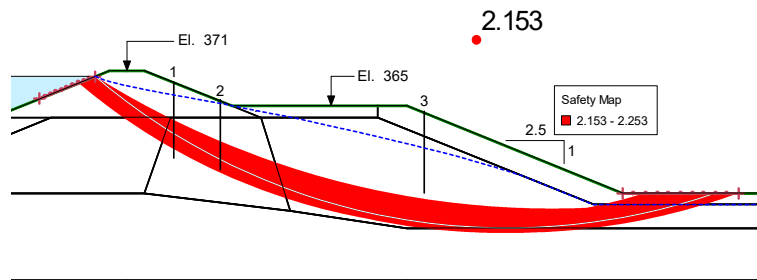
**Figure 19. Overall margin of safety before the earthquake.**

Based on the SEEP/W pore-water pressures and QUAKE/W static stresses, the factor of safety of the overall slope is well above 2.0 (Figure 19). This is consistent with the findings by Seed et al., who concluded that the margin of safety against instability under the static conditions was fairly high.

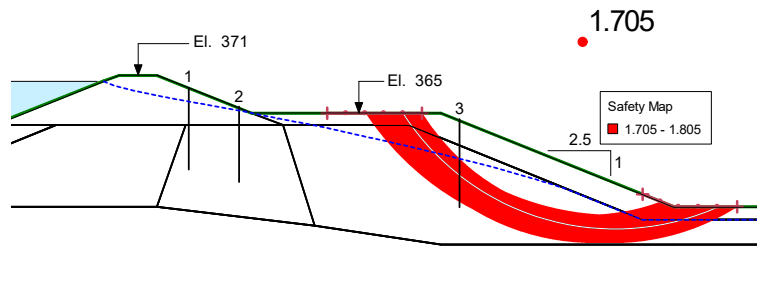
**Figure 20. Downstream slope margin of safety before the earthquake.**

The safety factor of the downstream slope of the hydraulic fill section is shown in Figure 20. As with the overall factor of safety, the factor of safety for this potential mode of failure is also fairly high. The factor of safety in the red band is between 1.70 and 1.80.

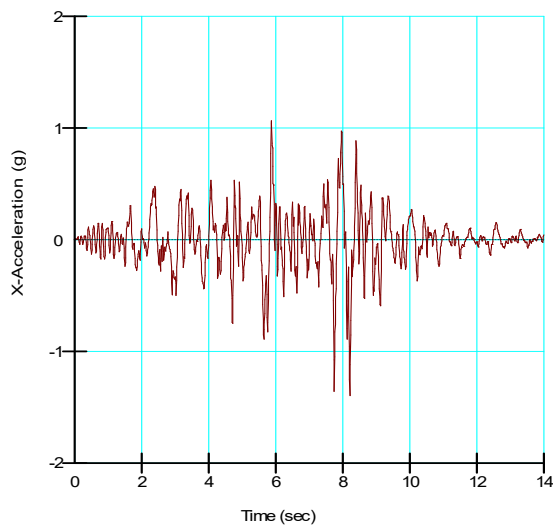
**Figure 21. Acceleration versus time at the Dam crest.**

Figure 21 shows the response at the History Point located at the crest of the Dam. There is not much difference between this record and the input record in Figure 13. There are a couple of spikes greater than 1g, but outside these spikes the response is more or less a reflection of the earthquake record. In other words, there is no significant amplification or unrealistic damping. This is consistent with the conclusions reached by Seed et al.

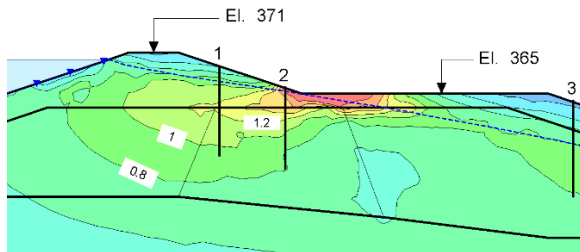
Figure 23.  $q/p'$  stress ratios under initial static stresses.

Figure 23 shows contours of  $q/p'$  stress ratios under the initial static stresses. A point of significance is the high  $q/p'$  ratios in the hydraulic fill underneath the dam crest. This means that there is a zone where the initial  $q/p'$  points are near the collapse surface, as discussed previously. The soil strength in this zone could easily fall down to the steady-state strength with a small amount of shaking. There is no yellow shaded area in Figure 24, which indicates that there is zone of initial stress states that are near but still below the collapse surface.

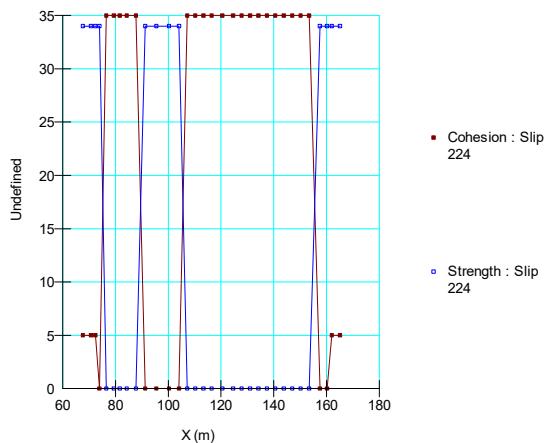
Figure 30. Strength along the overall critical slip surface.

Figure 30 shows the cohesive strength along the overall critical slip surface. Note how along much of the slip surface, the cohesion is at 35 kPa, which is the specified  $C_{ss}$ . Where  $C_{ss}$  is 35,  $\phi'$  is zero and, therefore, the frictional component of the strength is zero.
